**TOWN OF INGERSOLL
PARKS AND RECREATION DEPARTMENT
2009 ARENA ROOF STRUCTURE & ROOFING MEMBRANE REPORT
POW PETERMAN CONSULTING ENGINEERS**

Report No. R-137-09

RE: INGERSOLL AND DISTRICT MEMORIAL CENTRE

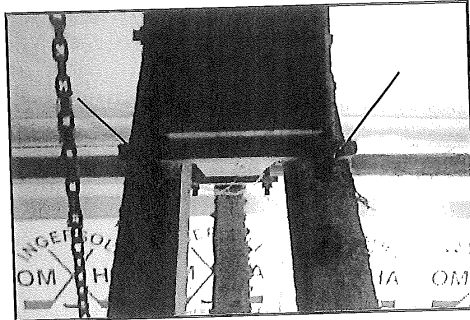
1. We examined the roof framing August 5, 2009, for signs of distress or deterioration by means of a man-lift. The majority of the roof deck and retro-fitted trusses are covered by the reflective ceiling. Where access was obtained, no signs of distress were noted.
2. We noted a high frequency of loose nuts on the clamping brackets for the retro-fitted parallam wood members.
3. We noted loose connections of the bottom chord bridging to the mainframes.
4. The bridging cross bracing is notably bowed and segmented.
5. With regard to the walls and foundations, we did not note any significant signs of distress.

We recommend that Item 2 be reworked before the next snow season. The additional items can be phased in as the schedule allows.

Check and tighten the clamping nuts on the parallam blocking at all locations to 30 foot-pounds. Penetrating oil should be utilized based on the surface rusting existing. Add nuts to the studs to double nut the connection. Undertake this work before the next snow season.
